SUBJECT: **Addendum 01**

Project Title: Renovations + Reconstruction

Address: 8 Gray Street | Binghamton, NY 13904

Specifications for the
LEAD-BASED PAINT ABATEMENT/ENCLOSURE AT
VACANT RESIDENTIAL PROPERTY IN BROOME
COUNTY, NY

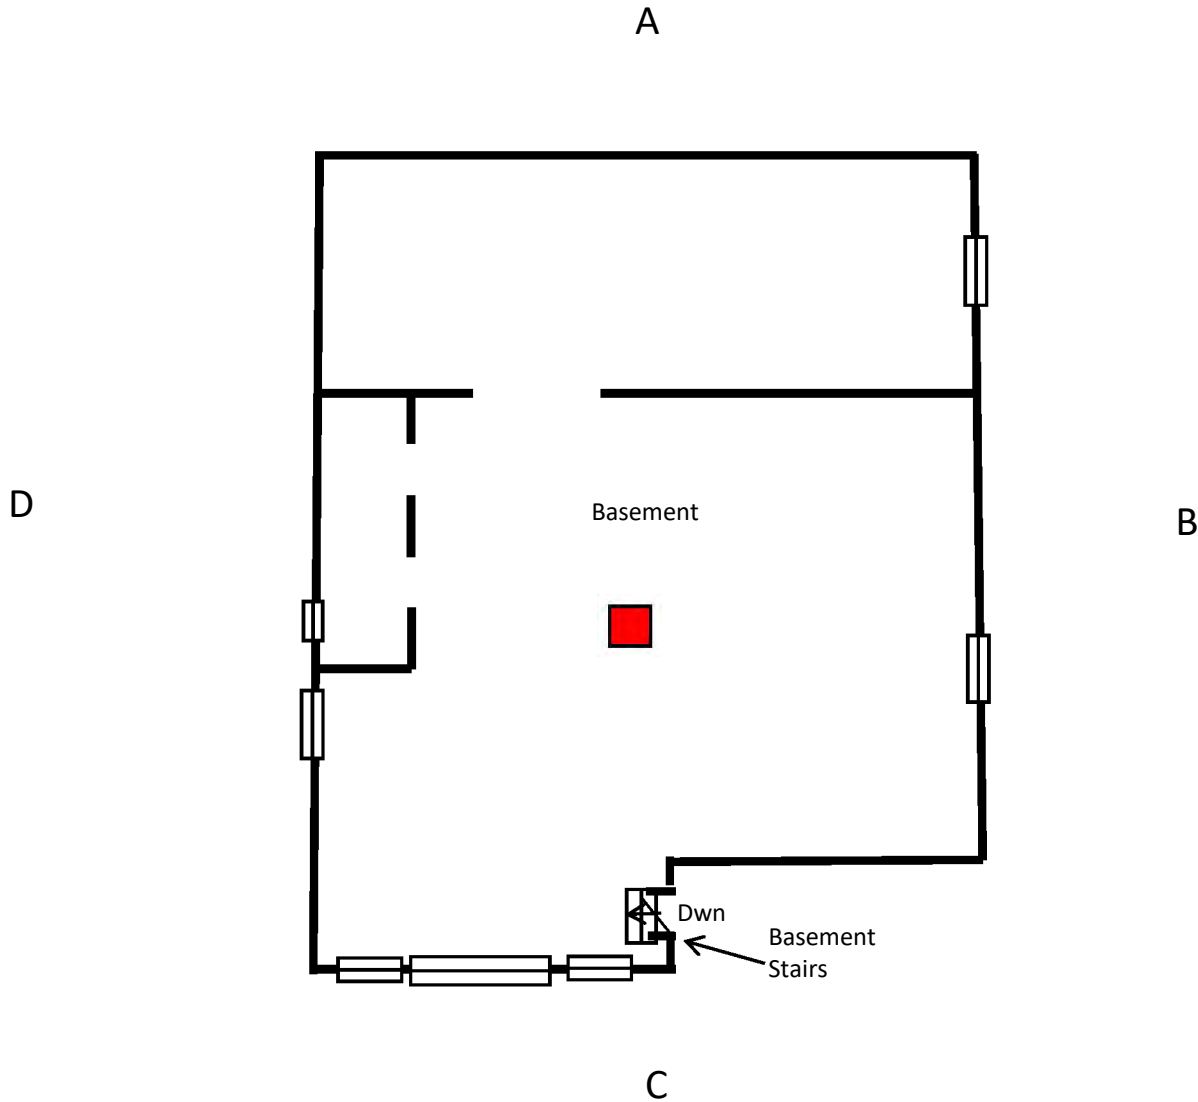
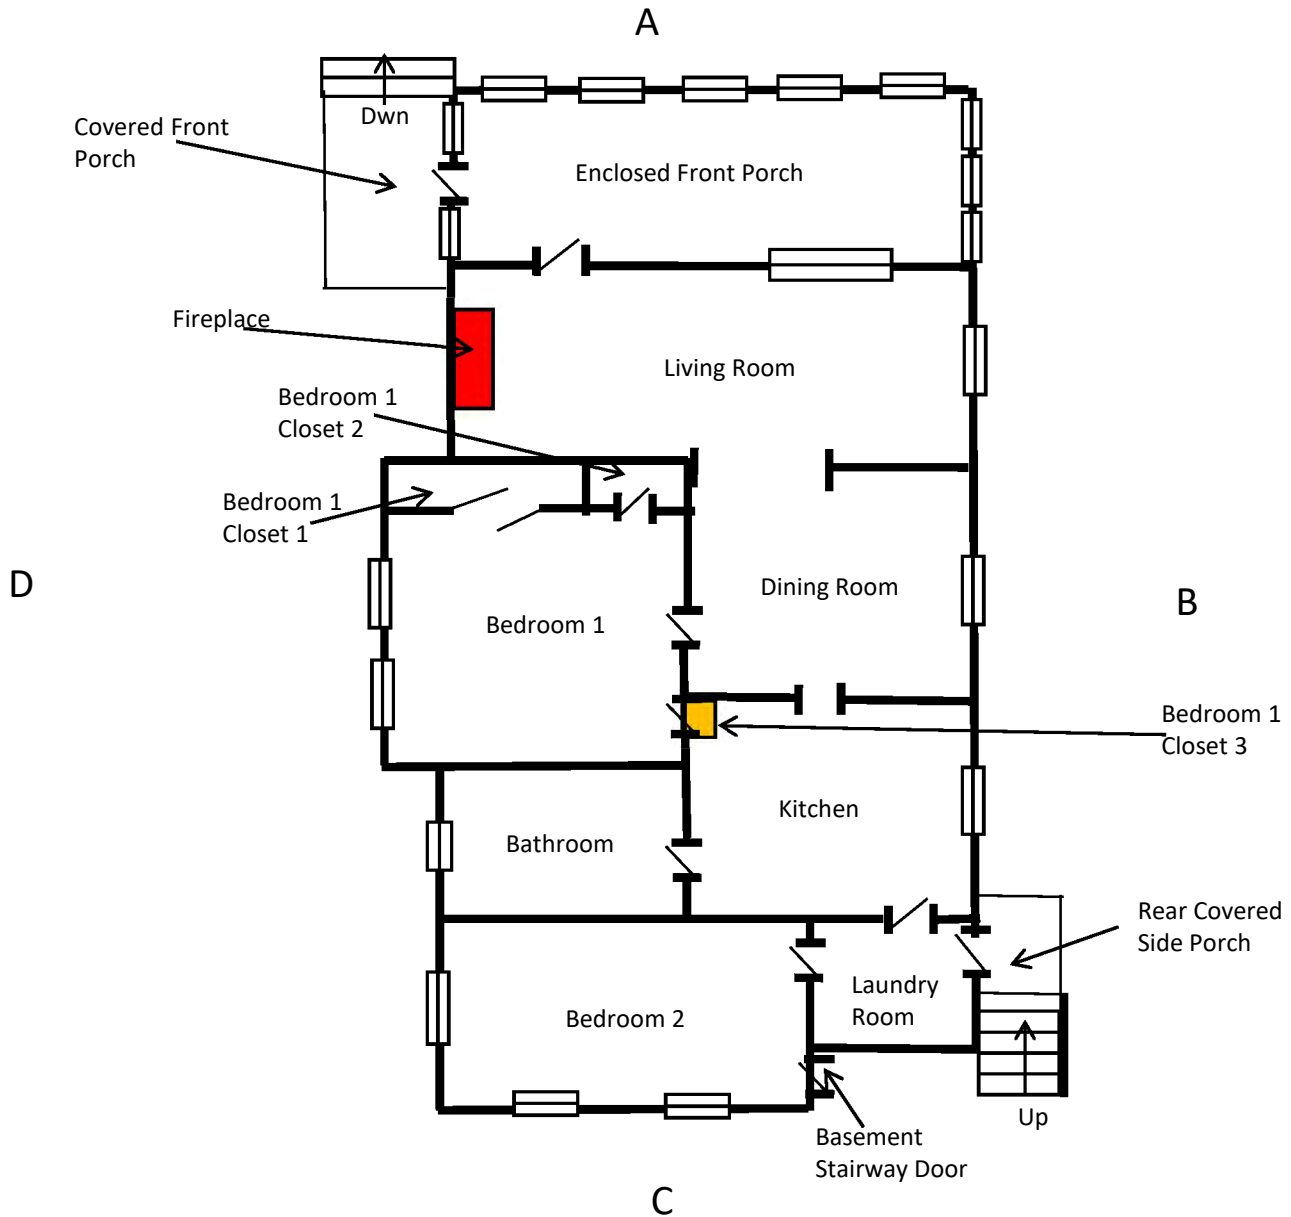
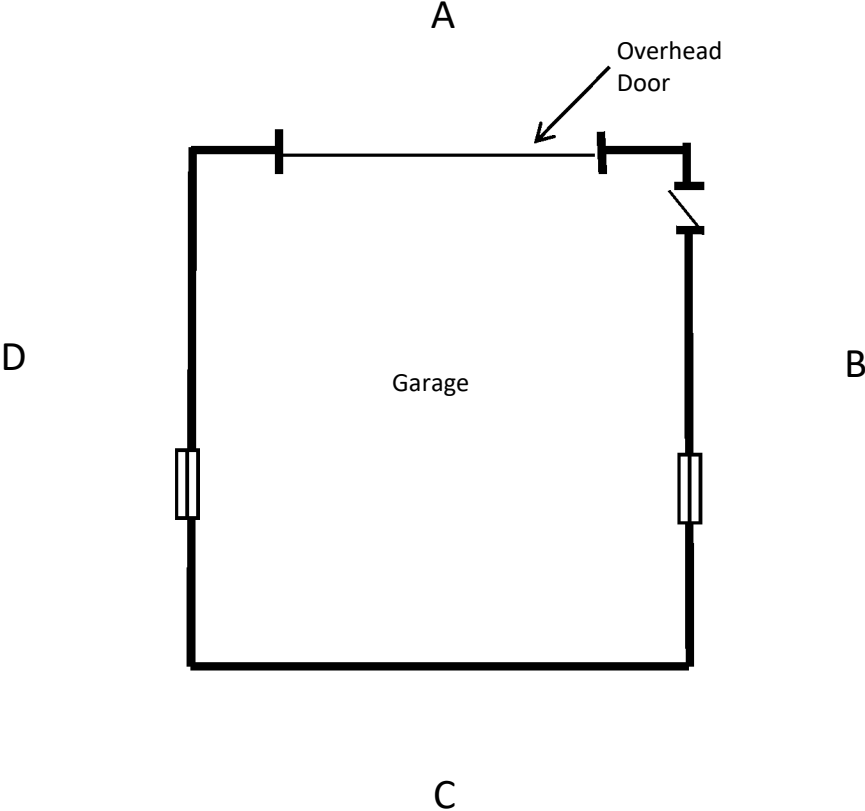
Drawings

8 Gray Street , 1st Floor, Binghamton, NY 13904
